### Urgent FSN of Percepta™ CRT-P MRI SureScan™ and Percepta™ Quad CRT-P MRI SureScan™ Pacemakers Manufactured by Medtronic

## Urgent Field Safety Notice

### Percepta™ CRT-P MRI SureScan™ and Percepta™ Quad CRT-P MRI SureScan™ Pacemakers Patient Management Recommendations

Medtronic reference: FA827

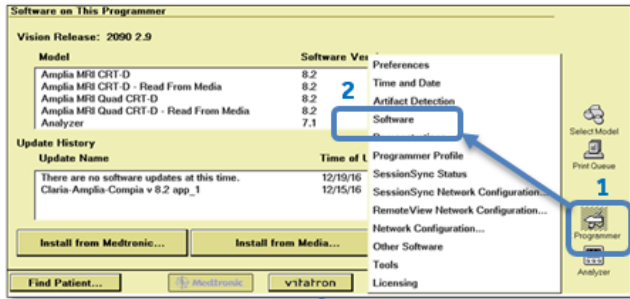
### Software Installation History Screen Image 1a

- Ensure the programmer has been updated to Percepta Application Software "Version 8.1" by viewing the software installation history under the Programmer Icon; Refer to Image 1a and 1b in Appendix A.
- Interrogate the patient's device; Print the Parameters Report – Verify the Device ID listed at the bottom of the printout displays "Device Configuration ID: 1-0-0" or "Device Configuration ID: 1-1-0"; Refer to Images 2a

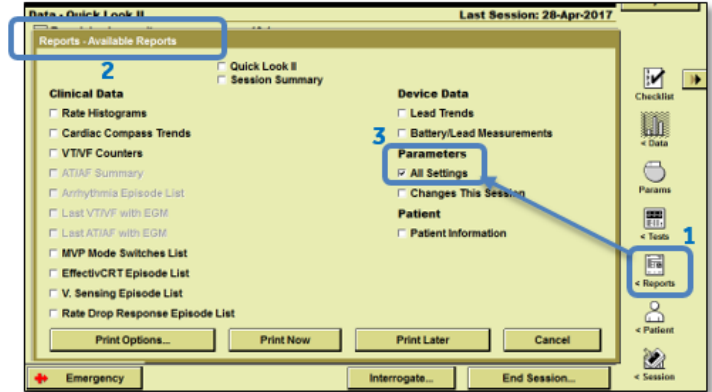
### Parameters Report- Device ID Information Image 2a

and 2b in Appendix A.

- If the Parameters Report does not display the new Device ID number, verify that the correct software application has already been installed (SW040 Version 8.1).
  - If the programmer has not been updated, install Software Application SW040 Version 8.1 and re-interrogate the patient's device.
  - If the programmer has been updated and the Device Configuration ID is not 1-0-0 or 1-1-0, the patient's device was unable to successfully receive the update. Contact Medtronic Technical Services for additional instructions.
